Navajo Abandoned Uranium Mine

Site Screen Report

Mesa IV, Mine No. 2 AUM Site

Navajo AUM Northern Region

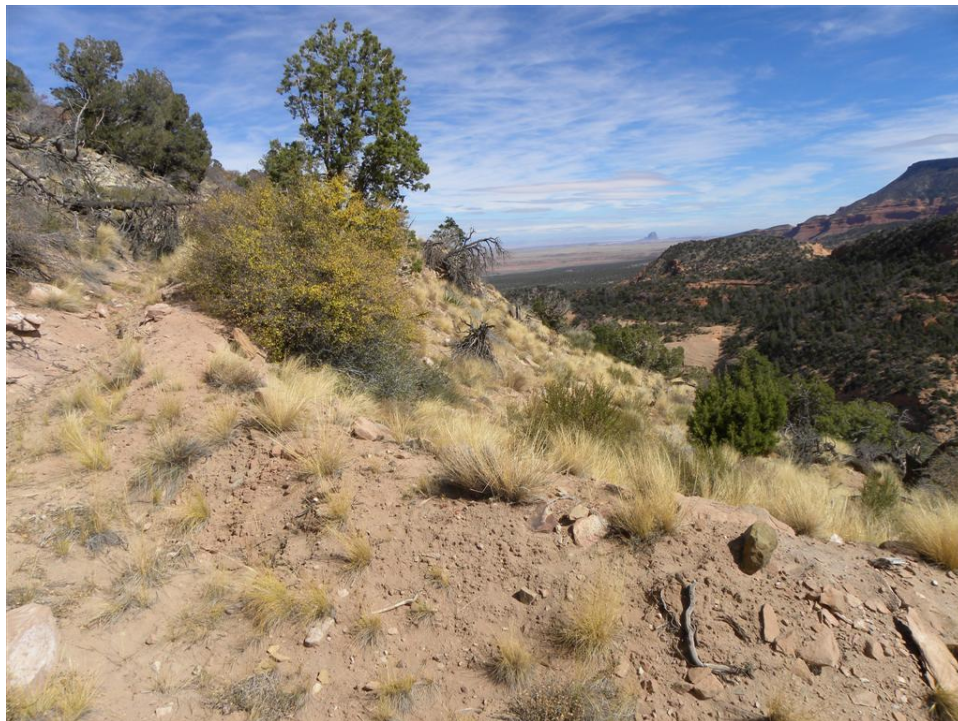
Photo 1. Mine site

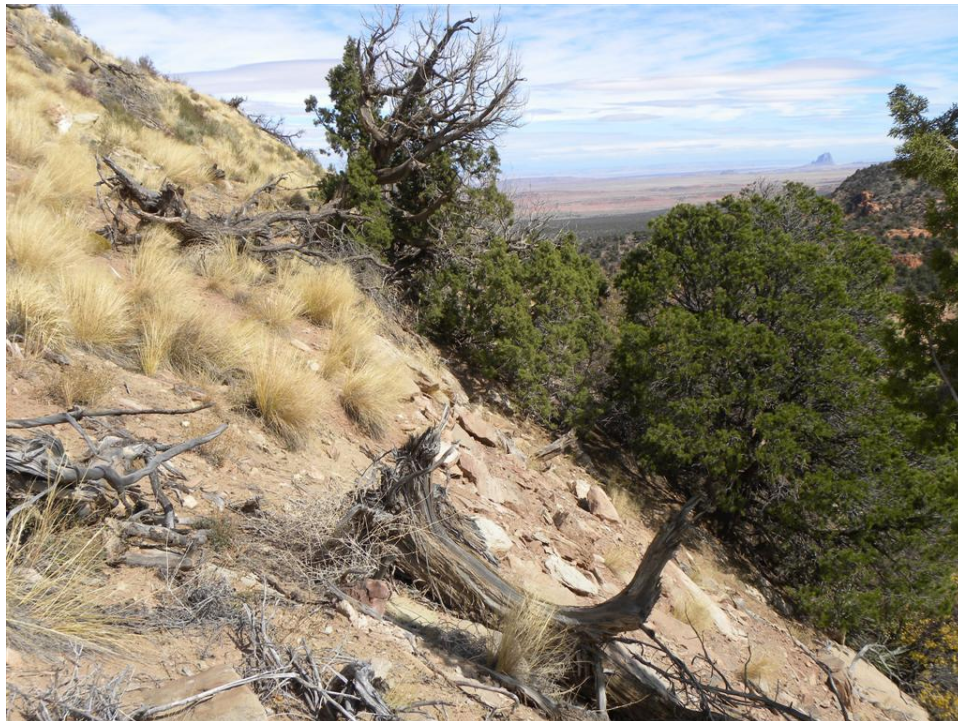
Photo 2. Slope area

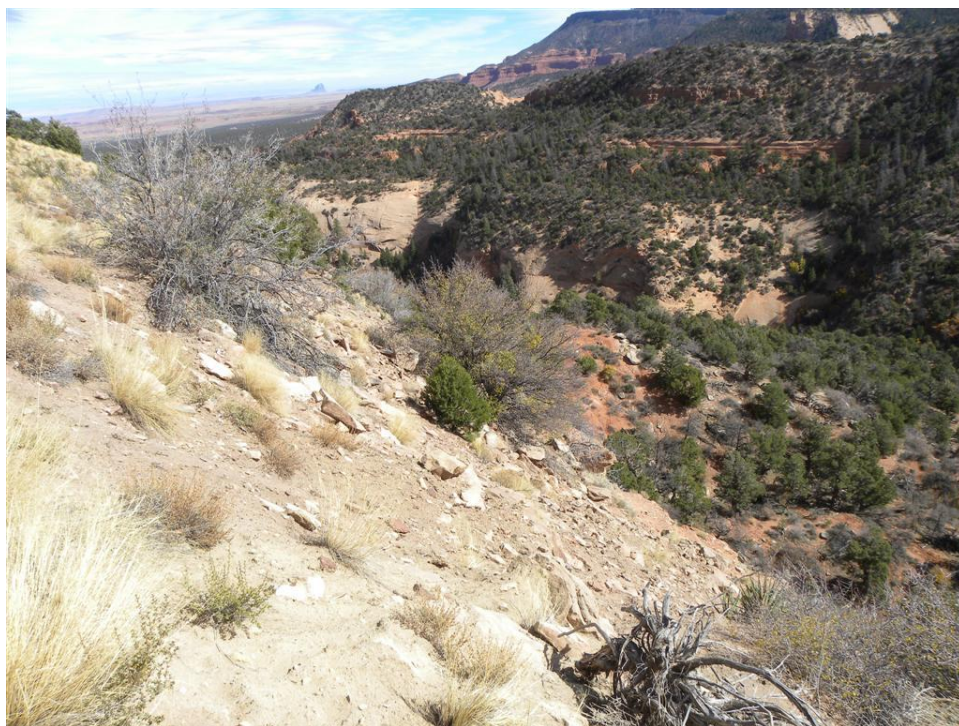
Waste rock throughout east portion of site, with a total estimated volume of 1,500 yd³

Photo 3. Slope area and waste debris

Unreclaimed waste pile
